DEVELOPMENT OF REPAIR PROCESSES  
AND SOURCES FOR C/KC-135 AIRCRAFT  
WINDOWS/WINDSHIELDS

RICHARD J. OLSON

BATTELLE  
505 KING AVENUE  
COLUMBUS, OH 43201

SEPTEMBER 1994

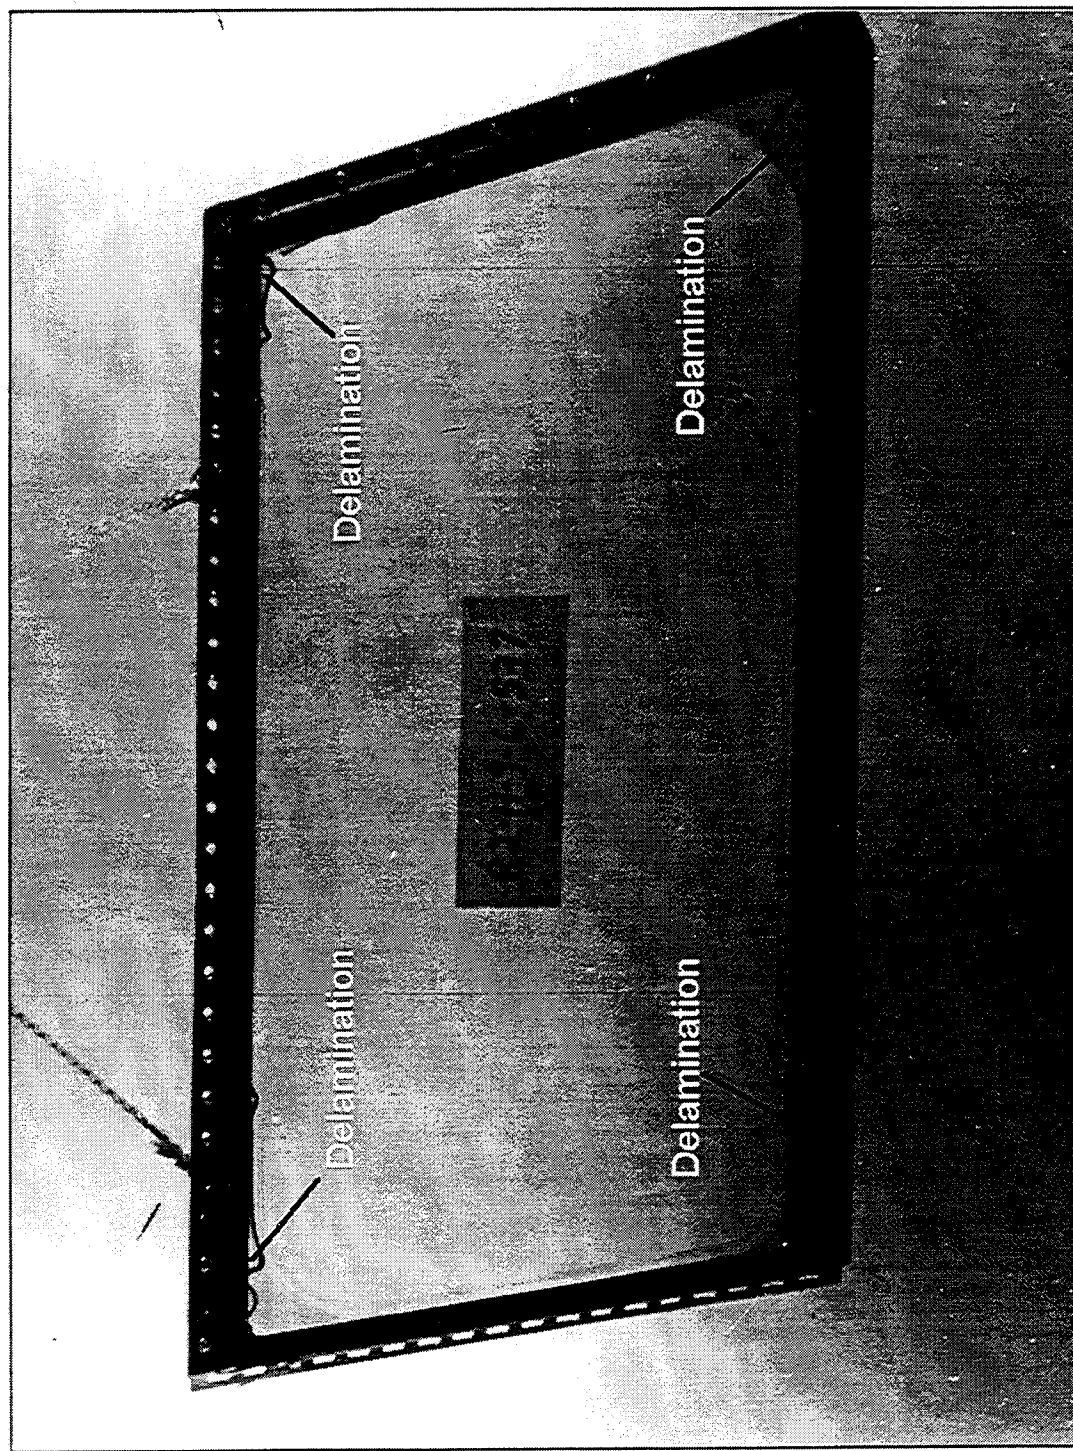
Figure 4.11 Worst Delamination Observed in a C/KC-I35 #1 W/WS From Pressure Cycling (Repaired W/WS, S/N 82-H-09-06-537)

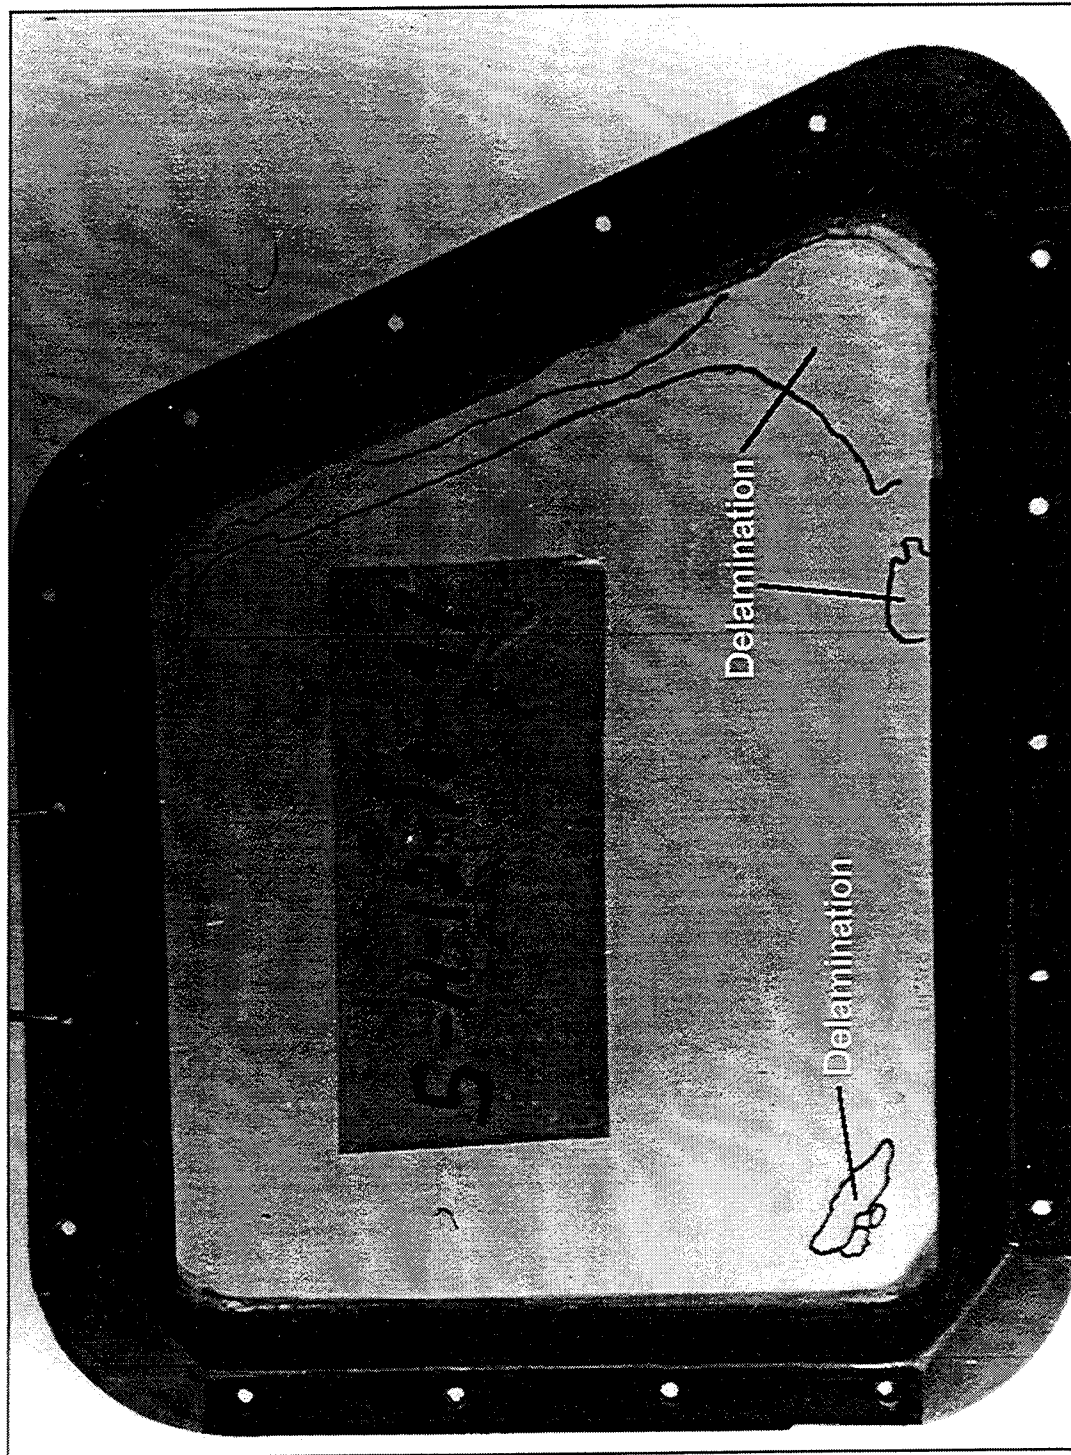
Figure 4.12 Worst Delamination Observed in a C/KC-135 #4 W/WS From Pressure Cycling (Repaired W/WS, S/N 5-H-12-16-47)

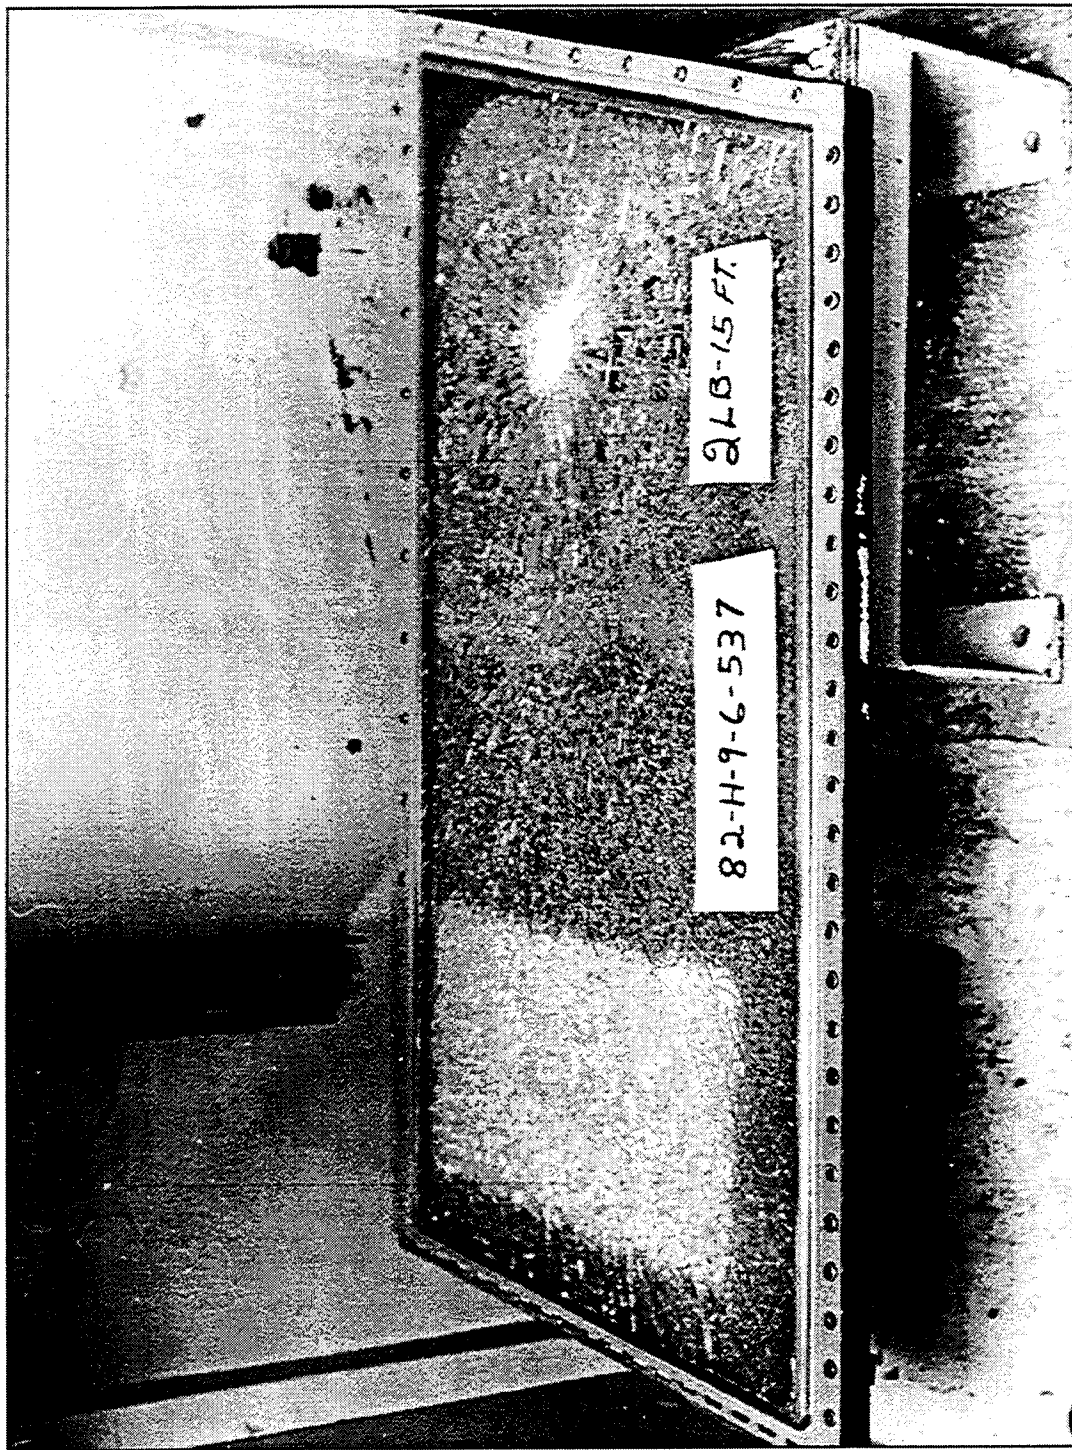
Figure 4.15 #1 W/WS Residual Strength Falling Ball Impact Test Result for a Repaired and Subsequently Delaminated W/WS, Single Ball Drop, Outboard View (S/N 82-H-9-6-537)

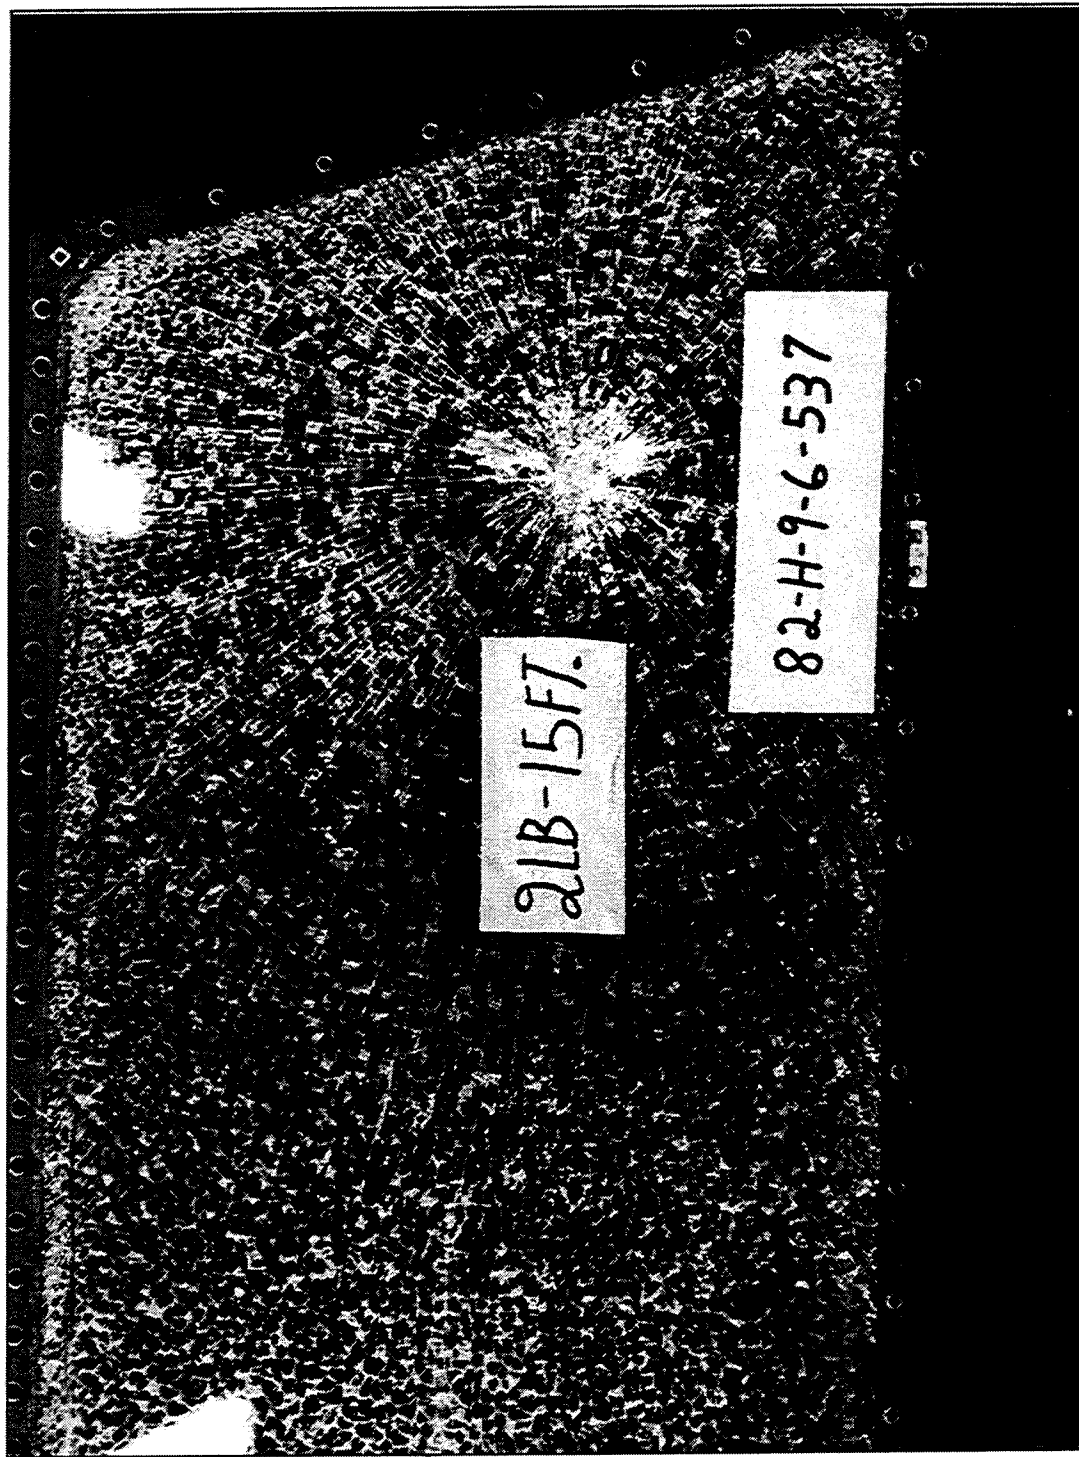
Figure 4.16 #1 W/WS Residual Strength Falling Ball Impact Test Result for a Repaired and Subsequently Delaminated W/WS, Single Ball Drop, Inboard View (S/N 82-H-9-6-537)

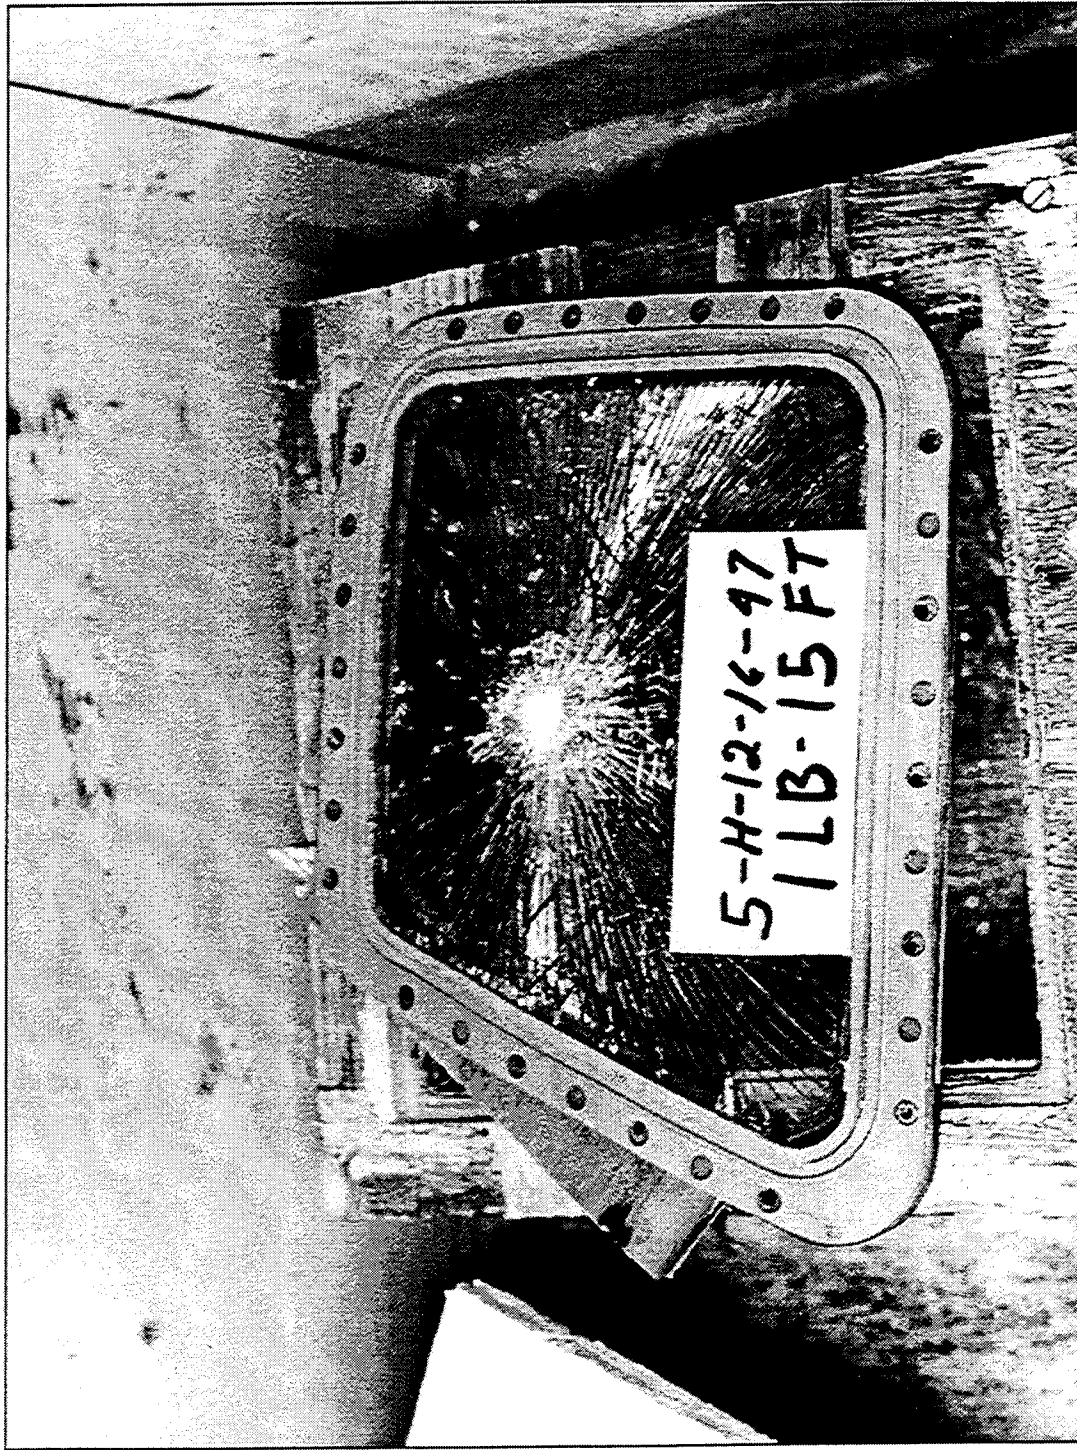
Figure 4.18 #4 W/WS Residual Strength Falling Ball Impact Test Result for a Repaired and Subsequently Delaminated W/WS, Outboard View  
(S/N 5-H-12-16-47)

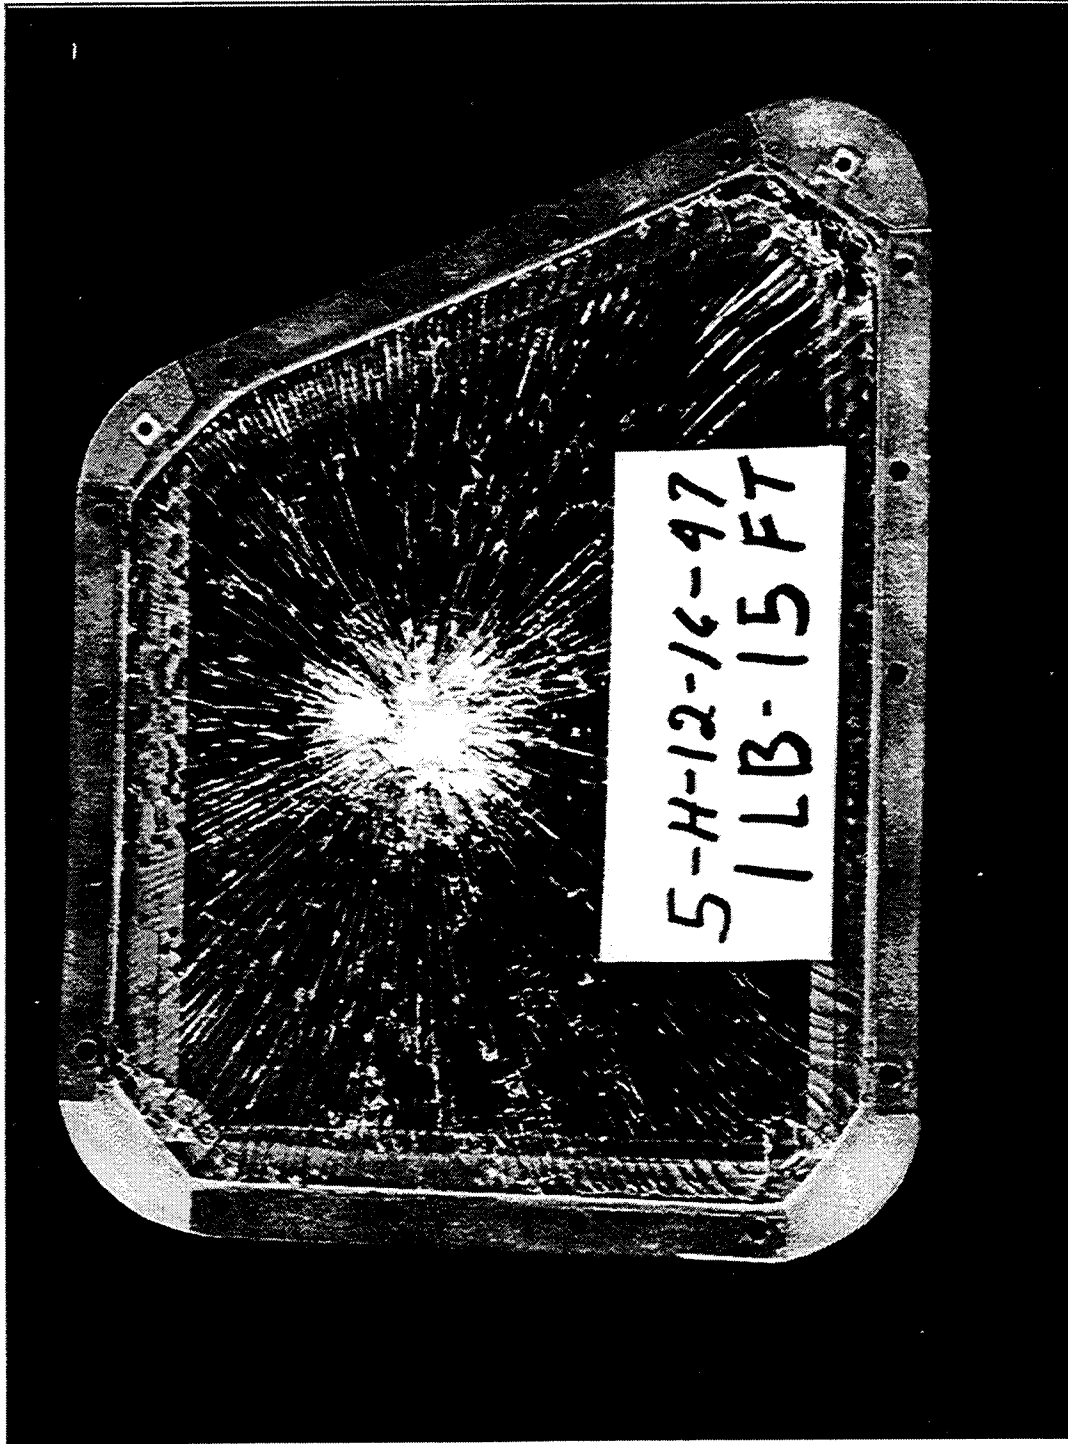
Figure 4.19 #4 W/WS Residual Strength Falling Ball Impact Test Result for a Repaired and Subsequently Delaminated W/WS, Inboard View  
(S/N 5-H-12-16-47)

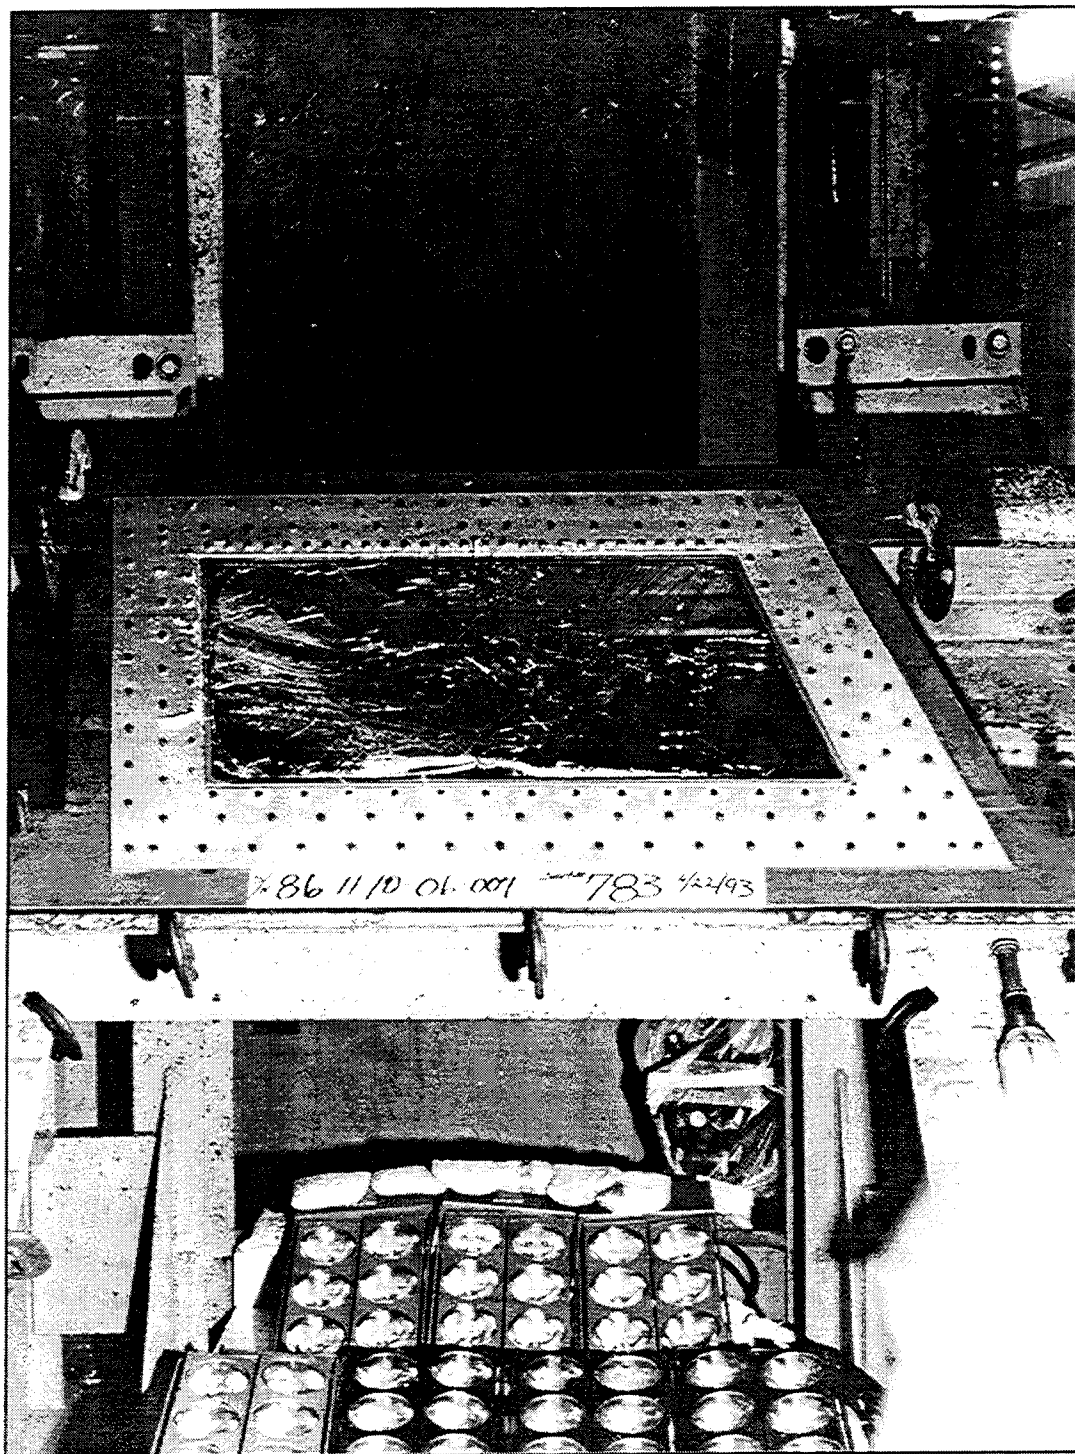
Figure 4.30 C/KC-135 #1 W/WS Showing Outboard Ply Failure From a 4-Pound Bird Impact at 251.7 Knots, Front View (New W/WS, S/N 86-H-10-06-007)

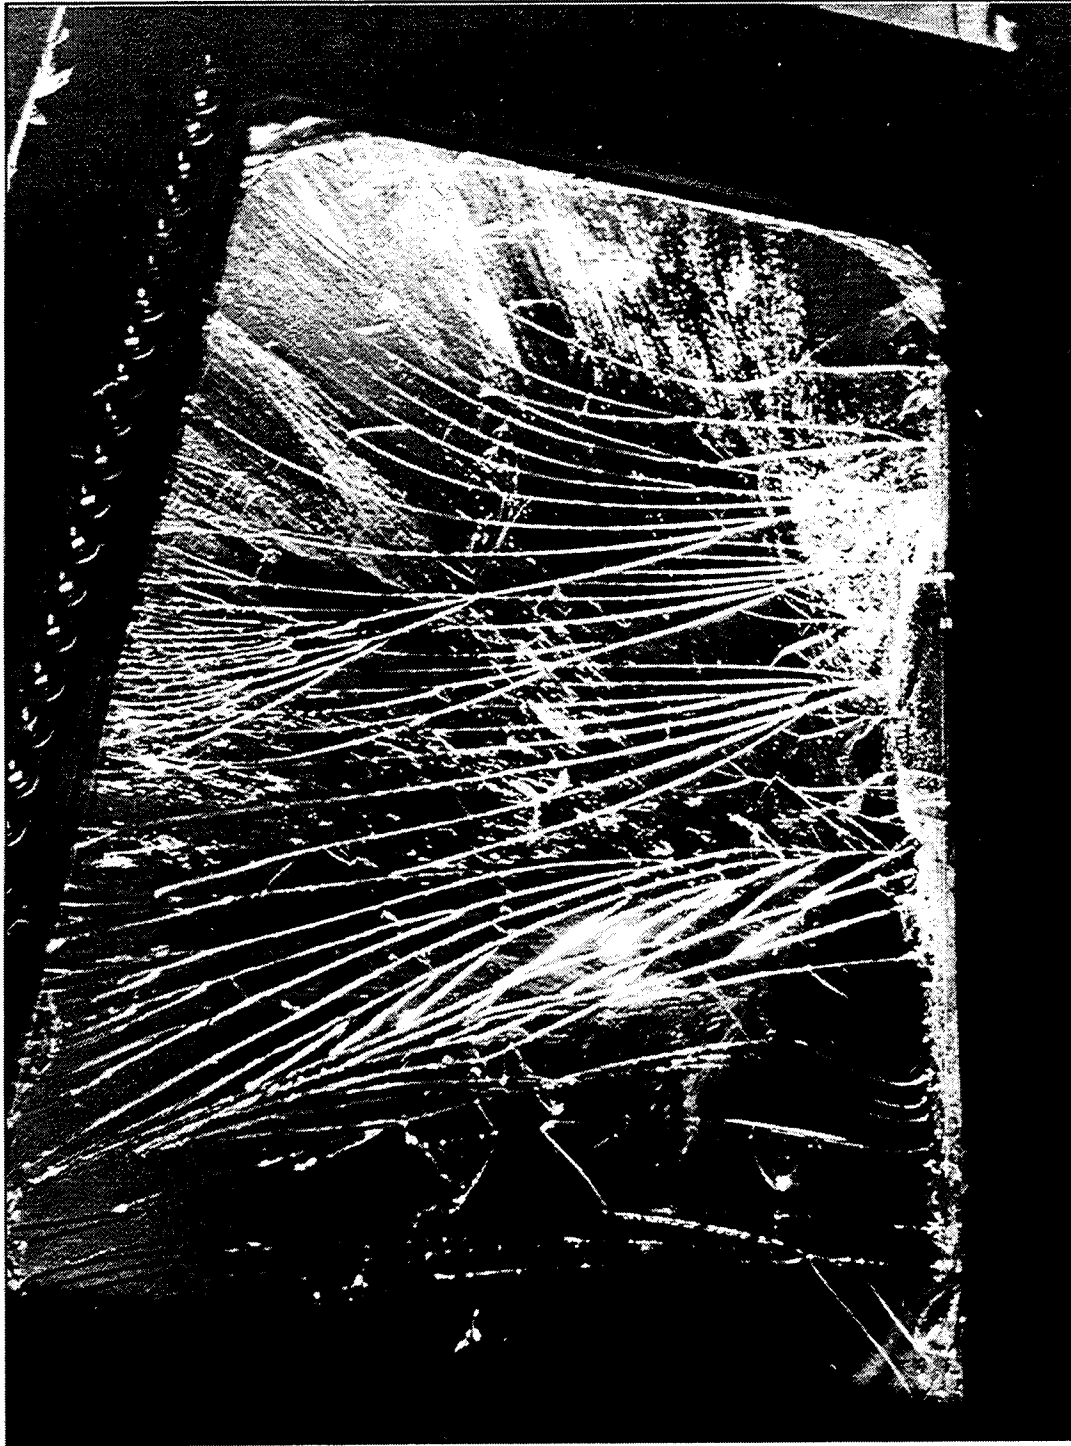
Figure 4.31 C/KC-135 #1 W/WS Showing Outboard Ply Failure From a 4-Pound Bird Impact at 251.7 Knots, Rear View  
(New W/WS, S/N 86-H-10-06-007)

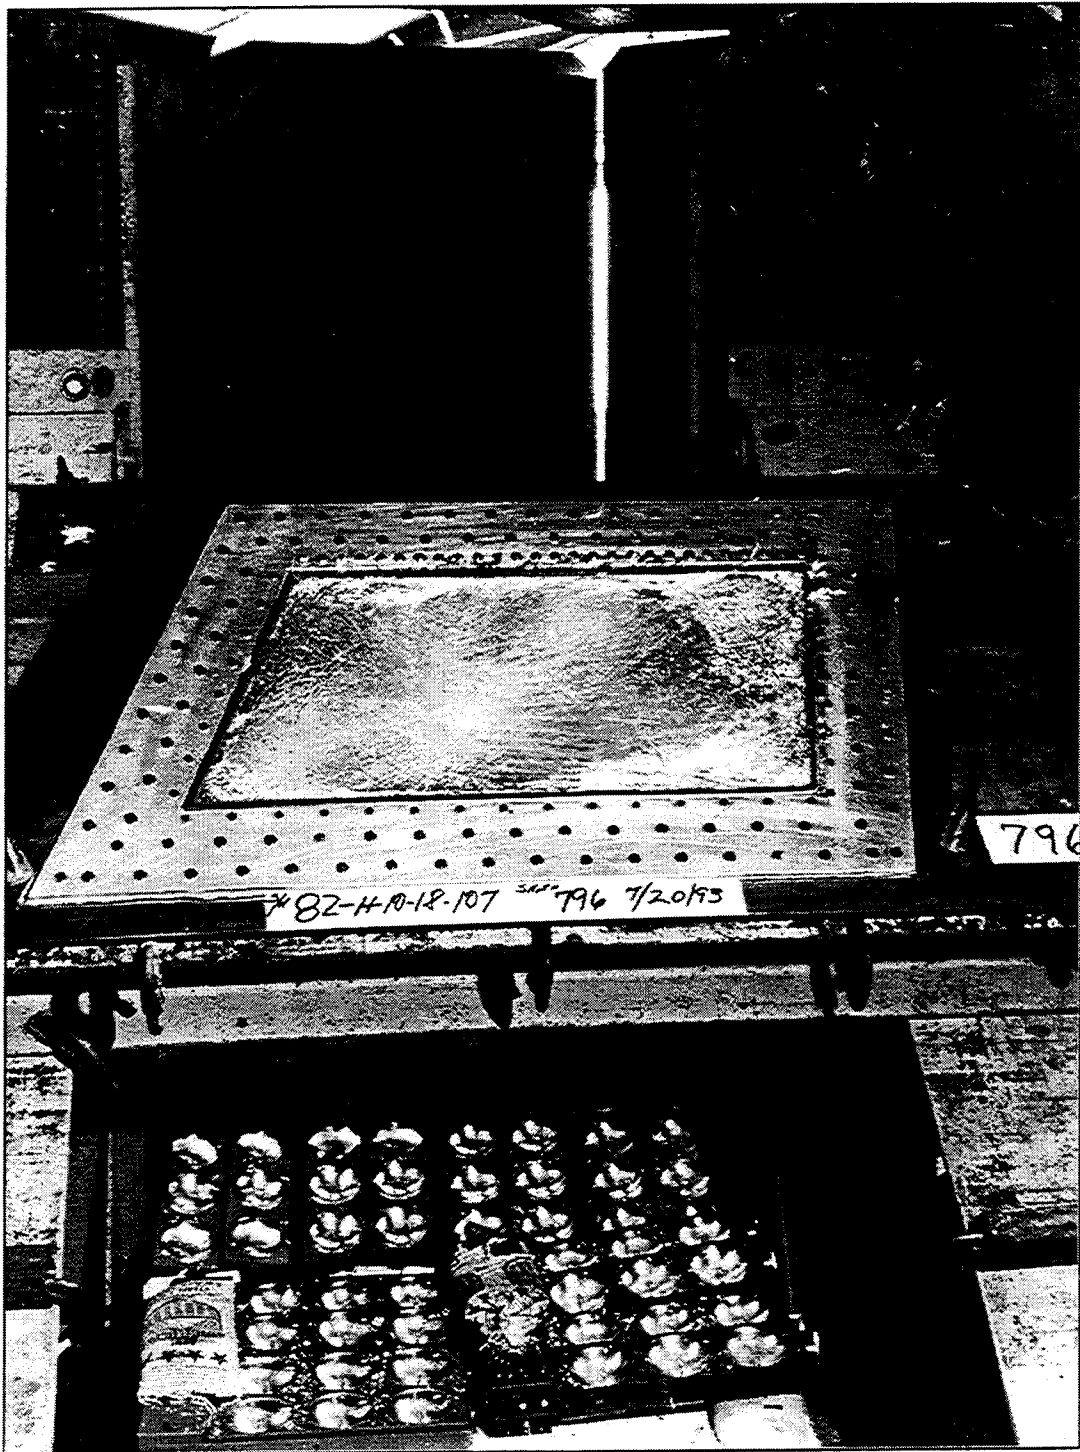
Figure 4.32 C/KC-135 #1 W/WS Showing All Glass Plies Failed From a 4-Pound Bird Impact at 249.4 Knots, Front View (Repaired W/WS, S/N 82-H-10-18-107)

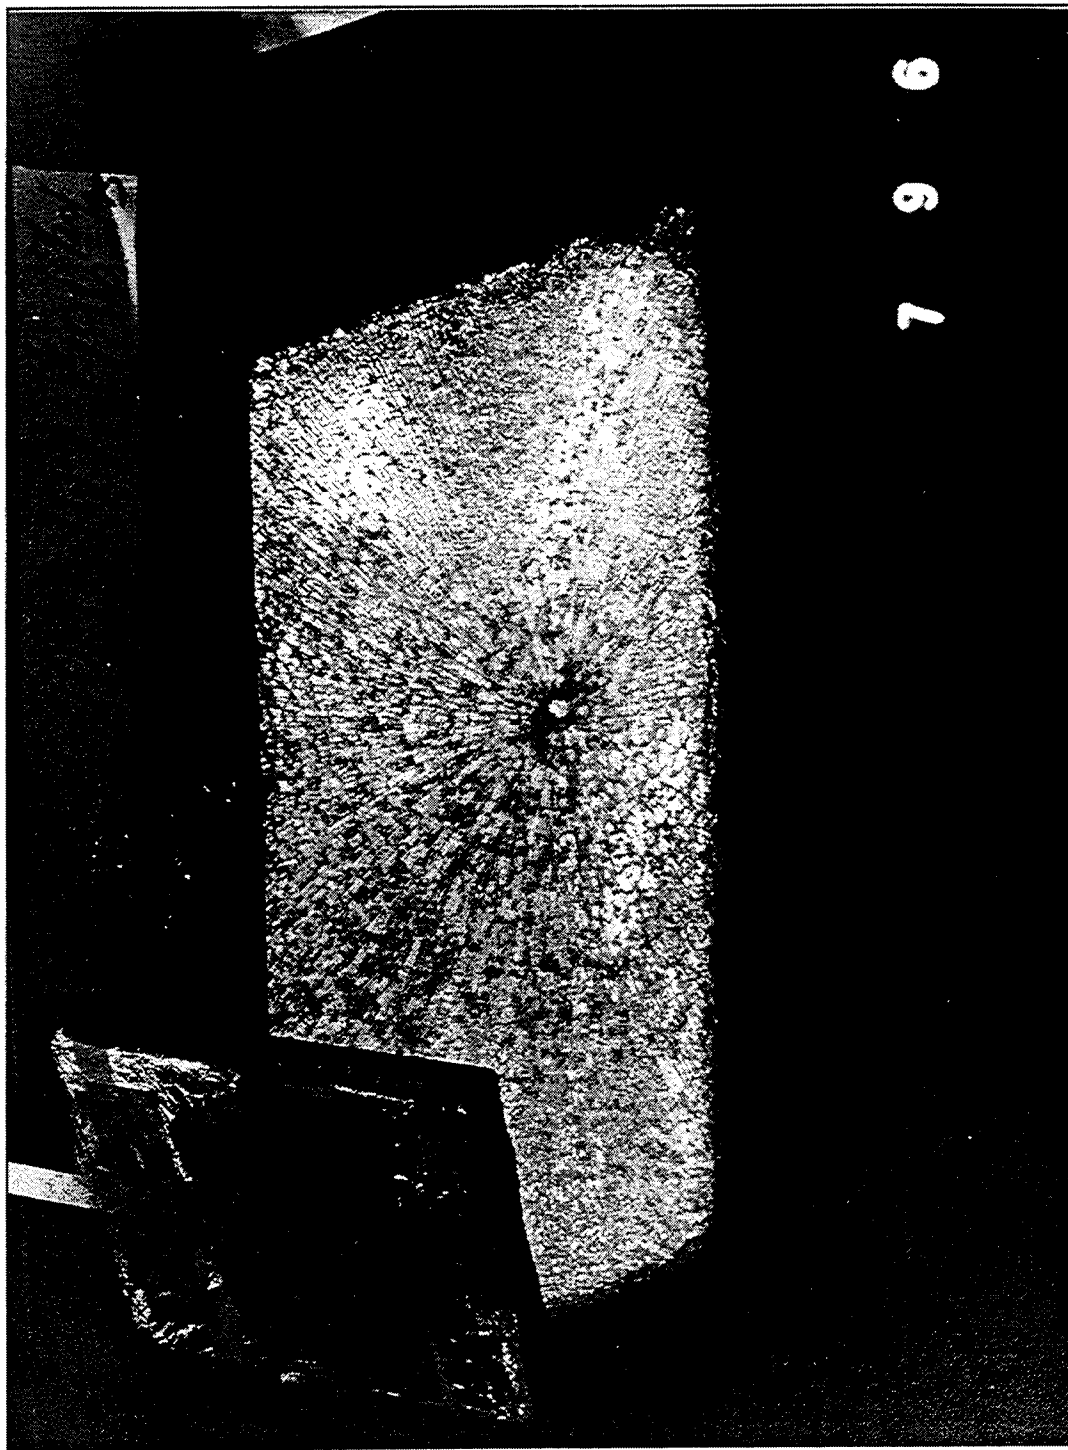
Figure 4.33 C/KC-135 #1 W/WS Showing All Glass Plies Failed From a 4-Pound Bird Impact at 249.4 Knots, Rear View  
(Repaired W/WS, S/N 82-H-10-18-107)

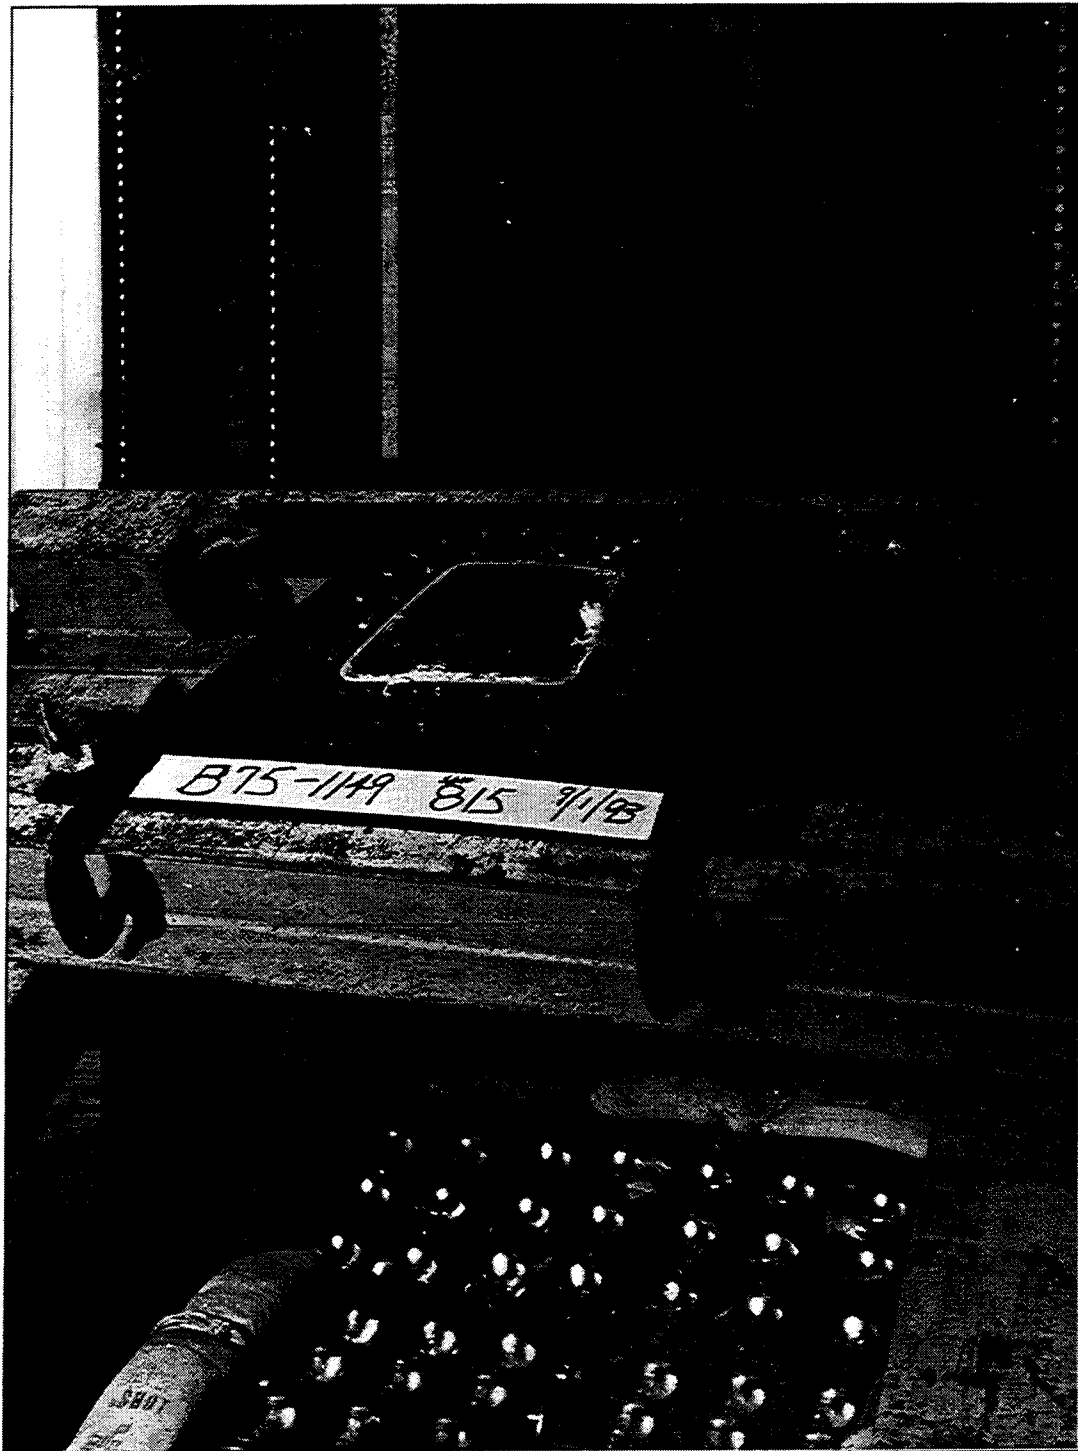
Figure 4.36 C/KC-135 #4 W/WS Showing Outboard Ply Failure From a 4-Pound Bird Impact at 247.5 Knots, Front View (Repaired W/WS, S/N B75-1149)

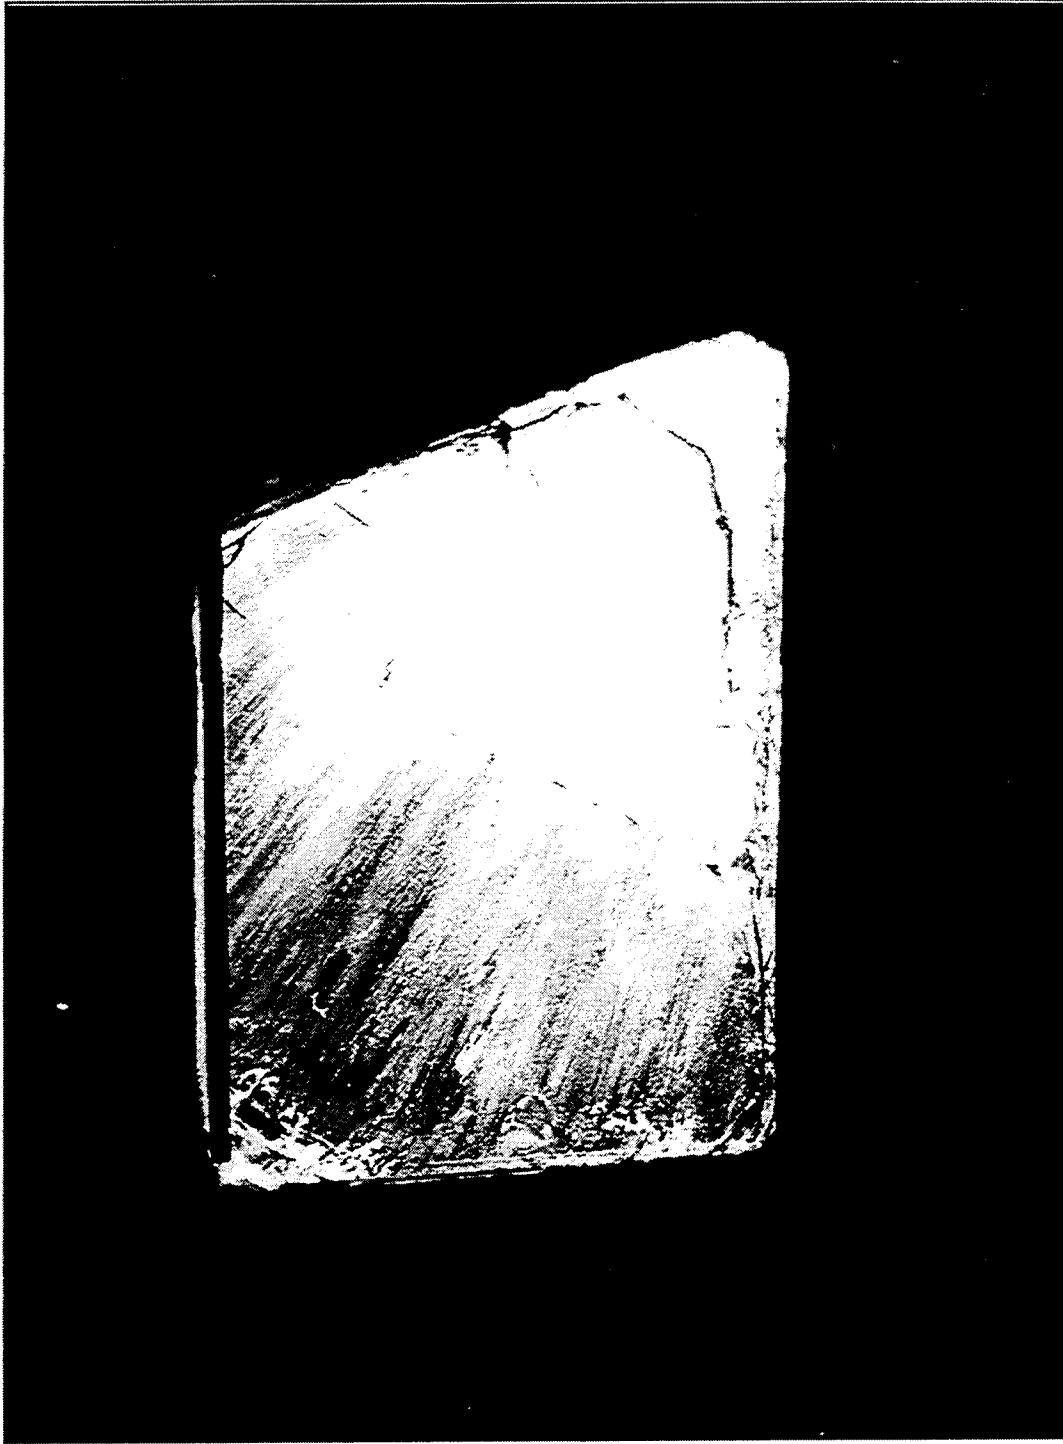
Figure 4.37 C/KC-135 #4 W/WS Showing Outboard Ply Failure From a 4-Pound Bird Impact at 247.5 Knots,  
Rear View (Repaired W/WS, S/N B75-1149)

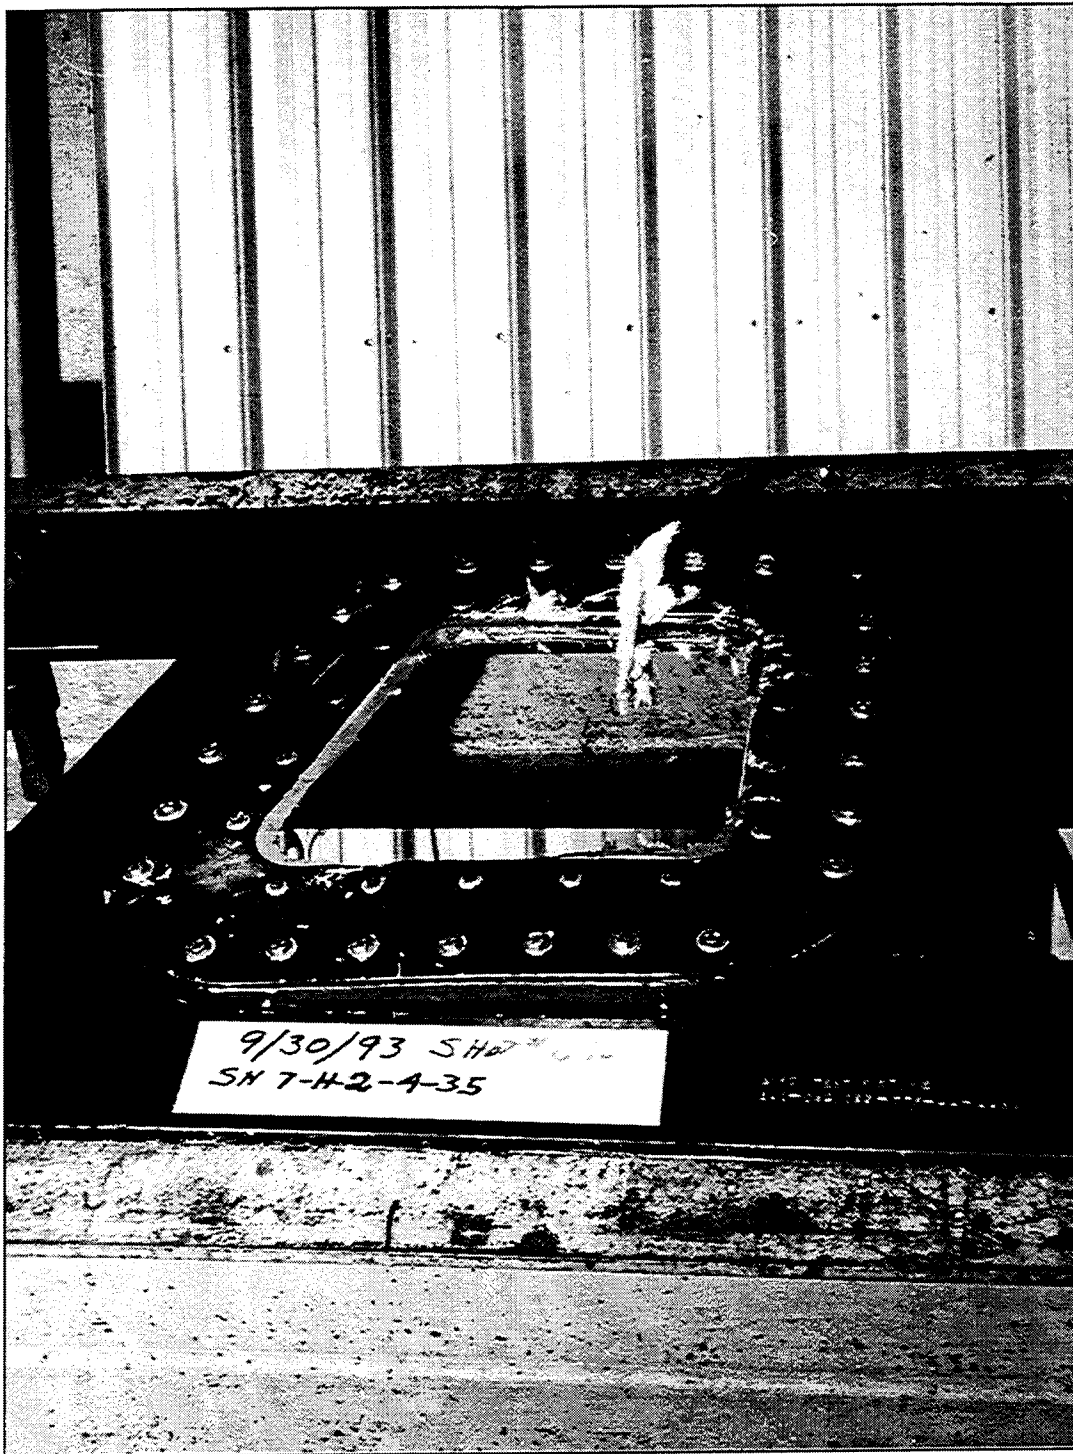
Figure 4.38 C/KC-135 #4 W/WS Showing a Catastrophic All Glass Plies Failure From a 4-Pound Bird Impact at 250.8 Knots, Front View (Not Repaired W/WS, S/N 7-H-2-4-35)

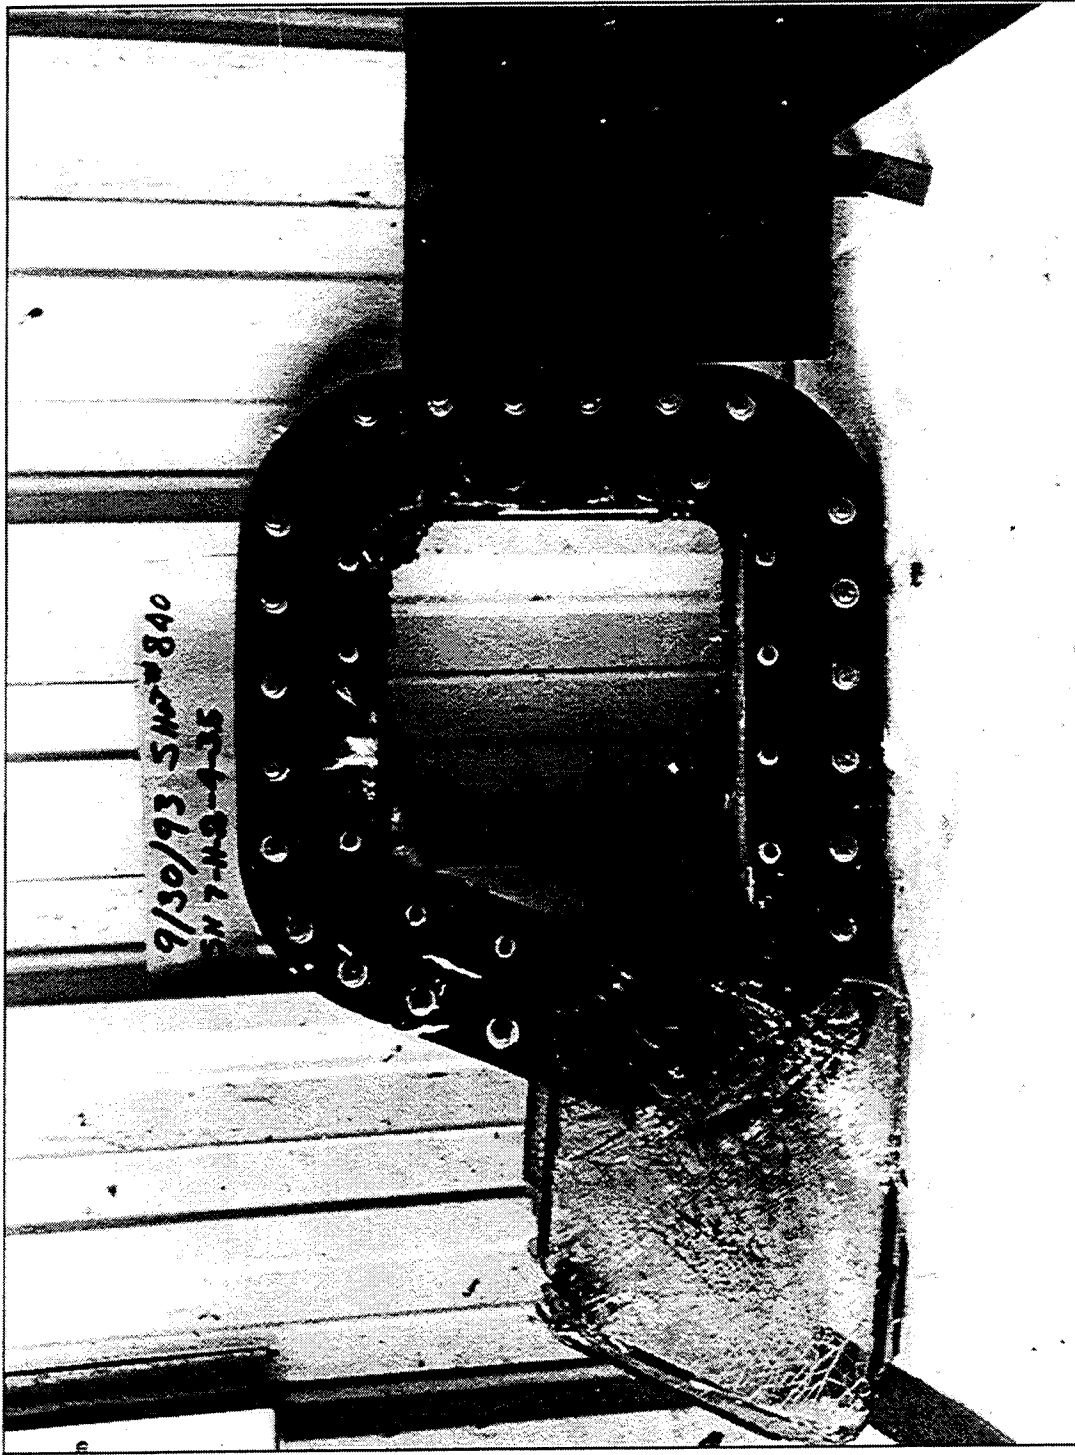
Figure 4.40 Spall Sheet and W/WS Condition From a Catastrophic 4-Pound Bird Impact at 250.8 Knots on a C/KC-135 #4 W/WS (Not Repaired W/WS, S/N 7-H-2-4-35)

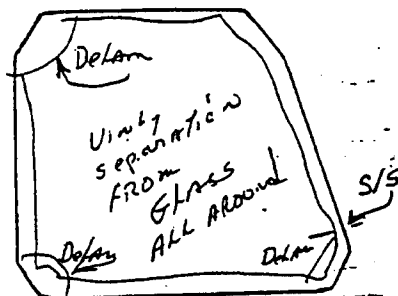
Vinyl separation from Glass edge ALL AROUND unit inside.

Delam AROUND unit in corner unit has surface scr. Remover Between ply.

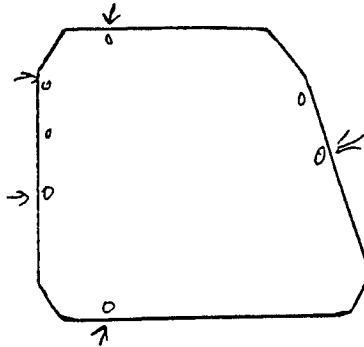
Seal Loose AS MARKED

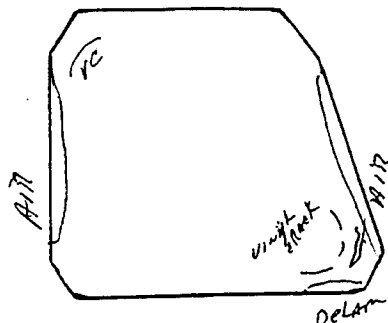
AIR Located ALL ROUND UNIT. plus A Large Amount Located Lower/Fwd. Along with delam Also Vinyl cracks believe to be starting

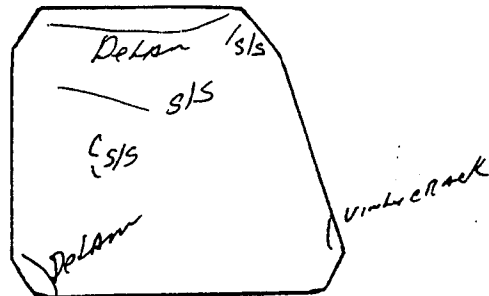
Delam as marked  
 surface SCR, as marked  
 vinyl crack as marked

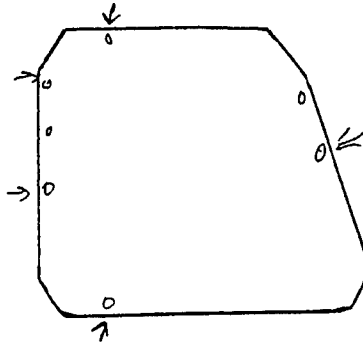
Seal Loose AS MARKED

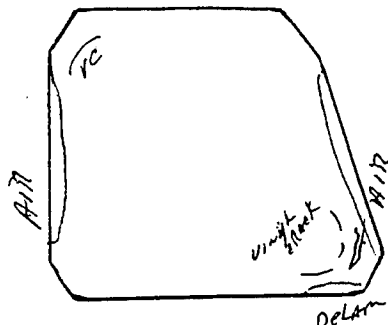
AIR Located ALL ROUND UNIT. plus A large  
Amount Located LOWER/FWD. Along with delam  
Also vinyl cracks believe to be starting
